Army Lodging Wellness Recommendation

Fort McCoy - Final Submittal

August 21, 2003

Section 1 Wellness Recommendation

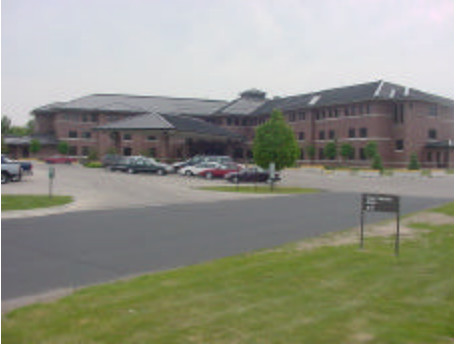
Lodging Building 51

Building 51, constructed in 2000, is a 3-story structure housing 214 standard rooms and 4 family suites. Ten of the rooms are accessible. The building is in excellent condition and meets a majority of current Army Lodging standards. This building is currently used to house Army Reserve Readiness Training Center Lodging requirements only.

Our recommendation is to retain building 51 in the McCoy Lodging inventory. This facility will remain in the in the Fort McCoy Wellness Solution and Lodging Master Plan.

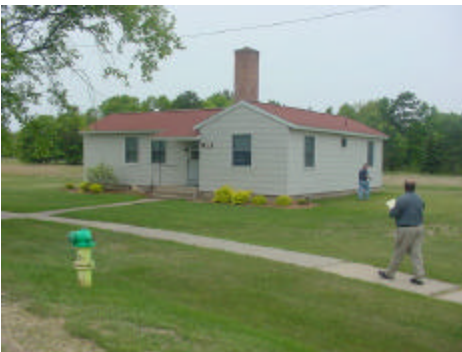
Lodging Building 105

Building 105, constructed in 1942, is a single story structure housing a single 2-bedroom suite with a full kitchen at 550 square feet. The building is in poor condition and does not meet current Army Lodging standards. The cost to make condition assessment improvements will exceed 50% replacement cost.

Our recommendation is to remove building 105 from the Lodging inventory, allowing the installation to determine an alternate use for the facility. This facility will be removed from the Fort McCoy Wellness Solution and Lodging Master Plan.

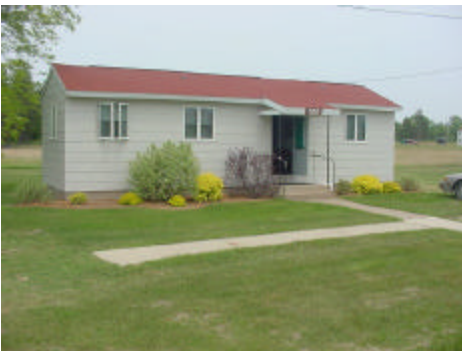
Lodging Building 108

Building 108, constructed in 1942, is a single story structure housing a single 2-bedroom suite with a full kitchen at 600 square feet. The building is in poor condition and does not meet current Army Lodging standards. Although the cost to make condition assessment improvements is just over the 50% replacement cost, it is our recommendation to remove this facility from the lodging inventory since it does not meet Army Lodging standard size and space requirements.

Our recommendation is to remove building 108 from the Lodging inventory, allowing the installation to determine an alternate use for the facility. This facility will be removed from the Fort McCoy Wellness Solution and Lodging Master Plan.

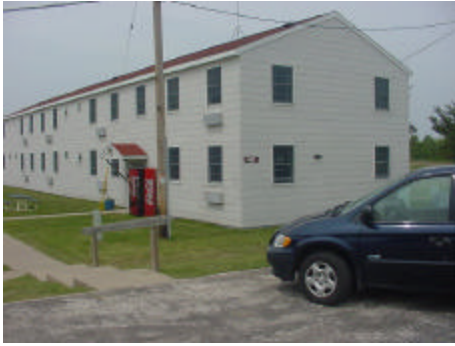
Lodging Building 451

Building 451, constructed in 1942 and renovated in 1998, is a 2-story structure housing 17 family suites without a full kitchen at 312 square feet. The building is in fair condition but does not meet current Army Lodging standards. The cost to make improvements and to bring this facility up to Army Lodging standards will exceed 50% of the replacement cost.

Our recommendation is to remove building 451 from the Lodging inventory, allowing the installation to determine an alternate use for the facility. This facility will be removed from the Fort McCoy Wellness Solution and Lodging Master Plan.

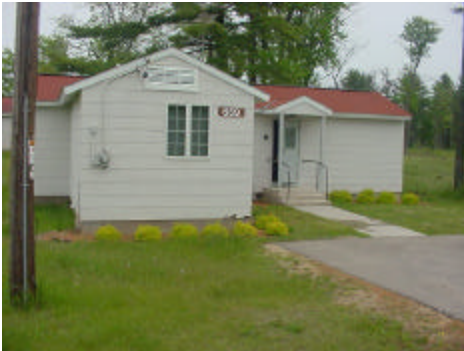
Lodging Building 659

Building 659, constructed in 1942 and renovated in 1999, is a single story structure housing a single 2-bedroom suite with a full kitchen at 370 square feet. The building is in poor condition and does not meet current Army Lodging standards. The cost to make condition assessment improvements will exceed 50% replacement cost.

Our recommendation is to remove building 659 from the Lodging inventory, allowing the installation to determine an alternate use for the facility. This facility will be removed from the Fort McCoy Wellness Solution and Lodging Master Plan.

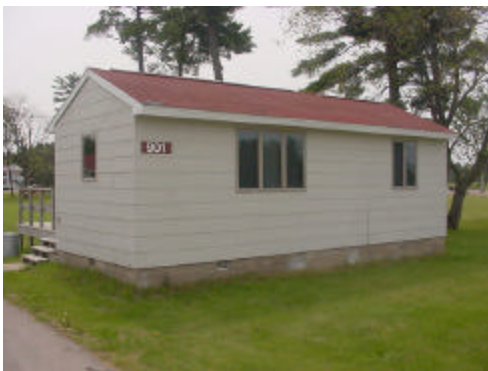
Lodging Building 901

Building 901, constructed in 1942 and renovated in 2000, is a single story structure housing a single 2-bedroom suite with a full kitchen at 550 square feet. The building is in good condition but does not meet current Army Lodging standards.

This building was removed from the Lodging inventory and returned to the installation in June 2003. This facility will be removed from the Fort McCoy Wellness Solution and Lodging Master Plan.

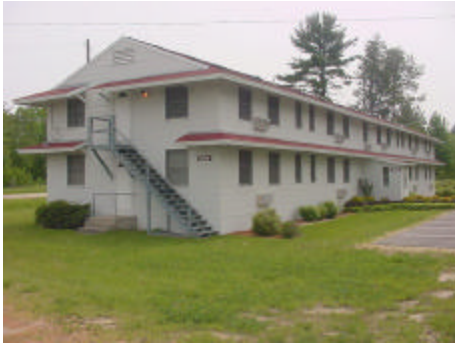
Lodging Building 904

Building 904, constructed in 1942 and renovated in 1989, is a 2-story structure housing 14 family suites without a full kitchen at 294 square feet, and 3 family suites without a full kitchen at 575 square feet. The building is in fair condition but does not meet current Army Lodging standards. The cost to make improvements and to bring this facility up to Army Lodging standards will exceed 50% of the replacement cost.

Our recommendation is to remove building 904 from the Lodging inventory, allowing the installation to determine an alternate use for the facility. This facility will be removed from the Fort McCoy Wellness Solution and Lodging Master Plan.

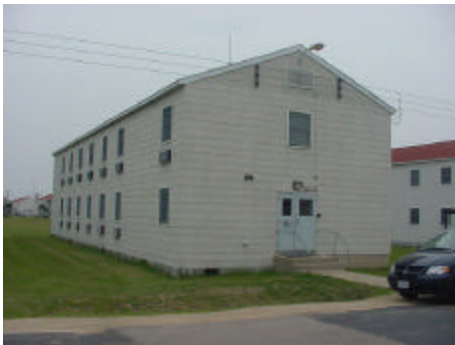
Lodging Building 1208

Building 1208, constructed in 1942 and renovated in 1989, is a 2-story structure housing 13 standard rooms at 250 square feet. The building is in fair condition but does not meet current Army Lodging standards. The cost to make improvements and to bring this facility up to Army Lodging standards will exceed 50% of the replacement cost.

Our recommendation is to remove building 1208 from the Lodging inventory, allowing the installation to determine an alternate use for the facility. This facility will be removed from the Fort McCoy Wellness Solution and Lodging Master Plan.

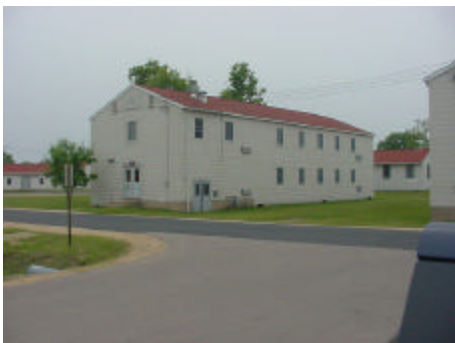
Lodging Building 1224

Building 1224, constructed in 1942 and renovated in 1989, is a 2-story structure housing 13 standard rooms. The building is in fair condition but does not meet current Army Lodging standards. The cost to make improvements and to bring this facility up to Army Lodging standards will exceed 50% of the replacement cost.

Our recommendation is to remove building 1224 from the Lodging inventory, allowing the installation to determine an alternate use for the facility. This facility will be removed from the Fort McCoy Wellness Solution and Lodging Master Plan.

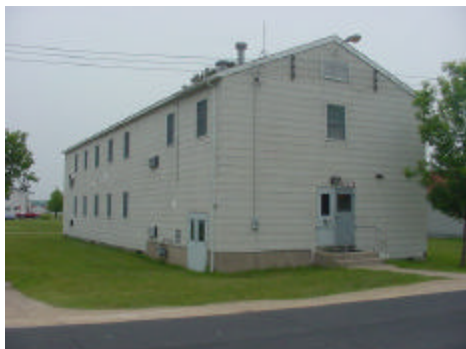
Lodging Building 1225

Building 1225, constructed in 1942 and renovated in 1989, is a 2-story structure housing 13 standard rooms. The building is in fair condition but does not meet current Army Lodging standards. The cost to make improvements and to bring this facility up to Army Lodging standards will exceed 50% of the replacement cost.

Our recommendation is to remove building 1225 from the Lodging inventory, allowing the installation to determine an alternate use for the facility. This facility will be removed from the Fort McCoy Wellness Solution and Lodging Master Plan.

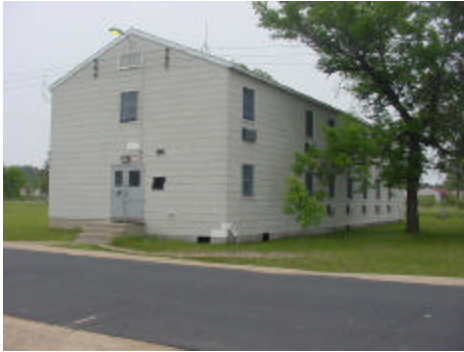
Lodging Building 1239

Building 1239, constructed in 1942 and renovated in 1989, is a 2-story structure housing 13 standard rooms. The building is in fair condition but does not meet current Army Lodging standards. The cost to make improvements and to bring this facility up to Army Lodging standards will exceed 50% of the replacement cost.

Our recommendation is to remove building 1239 from the Lodging inventory, allowing the installation to determine an alternate use for the facility. This facility will be removed from the Fort McCoy Wellness Solution and Lodging Master Plan.

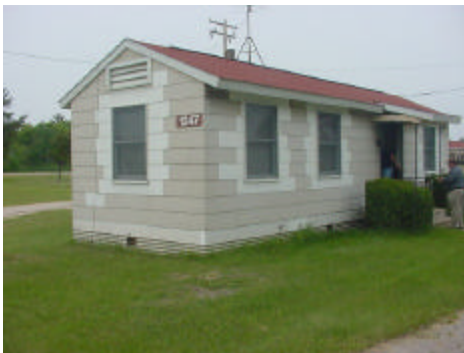
Lodging Building 1247

Building 1247, constructed in 1942, is a single story structure housing a single suite with a full kitchen at 540 square feet. The building is in poor condition and does not meet current Army Lodging standards. The cost to make condition assessment improvements will exceed 50% replacement cost.

Our recommendation is to remove building 1247 from the Lodging inventory, allowing the installation to determine an alternate use for the facility. This facility will be removed from the Fort McCoy Wellness Solution and Lodging Master Plan.

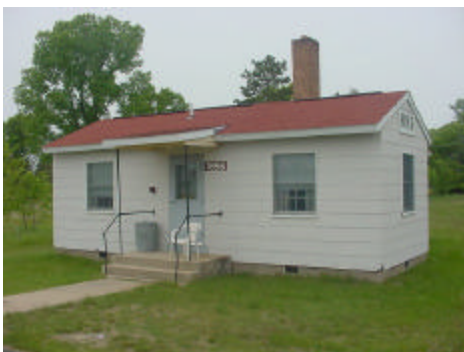
Lodging Building 1656

Building 1656, constructed in 1942, is a single story structure housing a single suite with a full kitchen at 415 square feet. The building is in poor condition and does not meet current Army Lodging standards. Although the cost to make condition assessment improvements is just over the 50% replacement cost, it is our recommendation to remove this facility from the lodging inventory since it does not meet Army Lodging standard size and space requirements.

Our recommendation is to remove building 1656 from the Lodging inventory, allowing the installation to determine an alternate use for the facility. This facility will be removed from the Fort McCoy Wellness Solution and Lodging Master Plan.

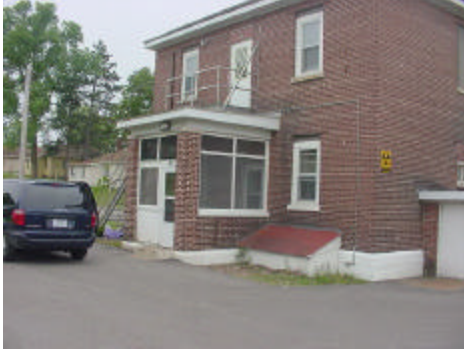
Lodging Room 7051C

Building 7051C, constructed in 1942, is part of a 2-story structure four-plex structure. Army Lodging has one single family suite in this building with a full kitchen at 500 square feet. The building is in fair condition but does not meet current Army Lodging standards. Although the pro-rata share of condition assessment cost and the renovation cost do not exceed the 50% replacement cost, it is our recommendation to remove this one unit from this building that belongs to housing, in order to consolidate it with the other Lodging units.

Our recommendation is to remove building 7051C from the Lodging inventory, allowing the installation to determine an alternate use for the facility. This facility will be removed from the Fort McCoy Wellness Solution and Lodging Master Plan.

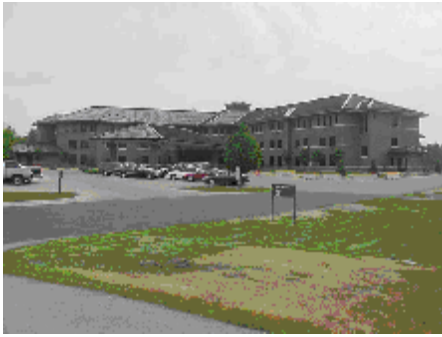
Building 0051

Building 51 was constructed in 2000. The 68,000 square foot facility contains 218 lodging units, 214 single room and 4 multi-room units, each without a full kitchen. 100 of the units are functioning as standard stay rooms, while 118 are functioning as extended stay rooms.

The renovation plan was not required because existing spaces meet current size requirements and the current building is in good condition to meet lodging requirements.

Because the Condition Assessment to Replacement Cost Ratio is less than 50%, continued use of Building 51 is recommended.
